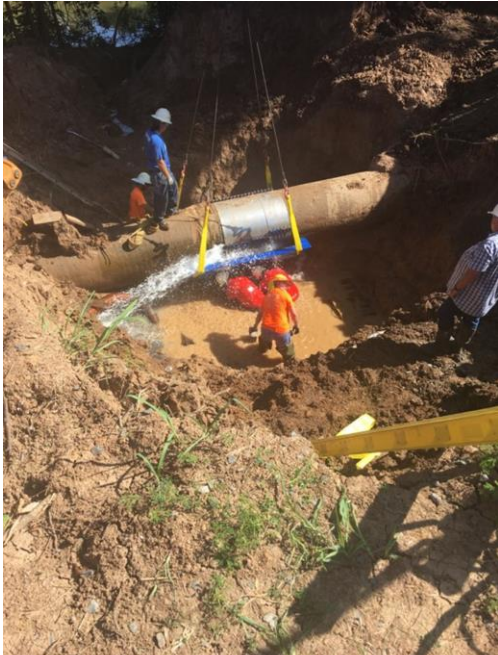
Smith-Blair provided a 54” full circle wrap around clamp about 10 years ago. It was to be considered a temporary repair as the municipality had intentions to install a permanent repair within a year. This bell pack will encapsulate the stainless clamp. Note the bottom half of sleeve at beginning stages of installation process.

There was no need to shutoff this main water system which would have left a large portion of the population without water for a long period of time. Just imagine if the municipality had decided to replace this damaged section as they originally planned to do.
